National Highway Traffic Safety Administration

Case Vehicle (A): 1998 Dodge Type: Durango 4 x 4, 4-door SUV

Veh. (B): 2000 Saturn Type: SL2, 4-door sedan Driver: 45-year-old female

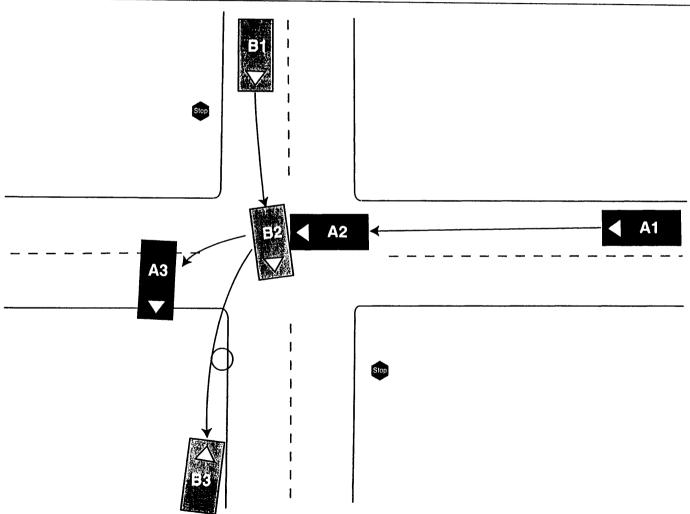
ACCIDENT DESCRIPTION: Case whicle (A) was traveling west and
whicle (B) was stopped tacing south, vehicle (D) attempted

to make a left tunn and pulled out in front of
case vehicle (A). Case vehicle (A) was unable to stop on quoid staiking vehicle

(B) and the front of case vehicle (A) stauck webicle (B) in the left sides

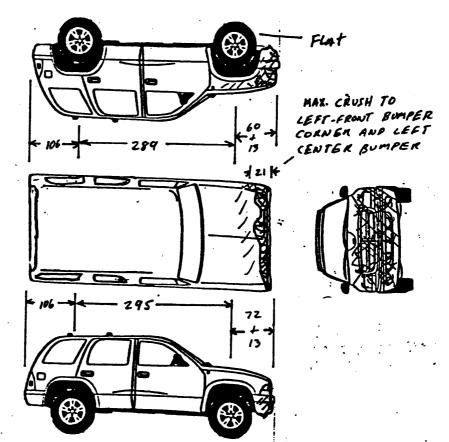
(Slide 5) Damage to case vehicle (A) was moderate. (Slide 6) Direct damage to case vehicle (A) began at the left-front bumper corner and extended 160 cm to the left across the entire front. The maximum crush was 21 cm in two places - the left-center bumper and left-front bumper corner.

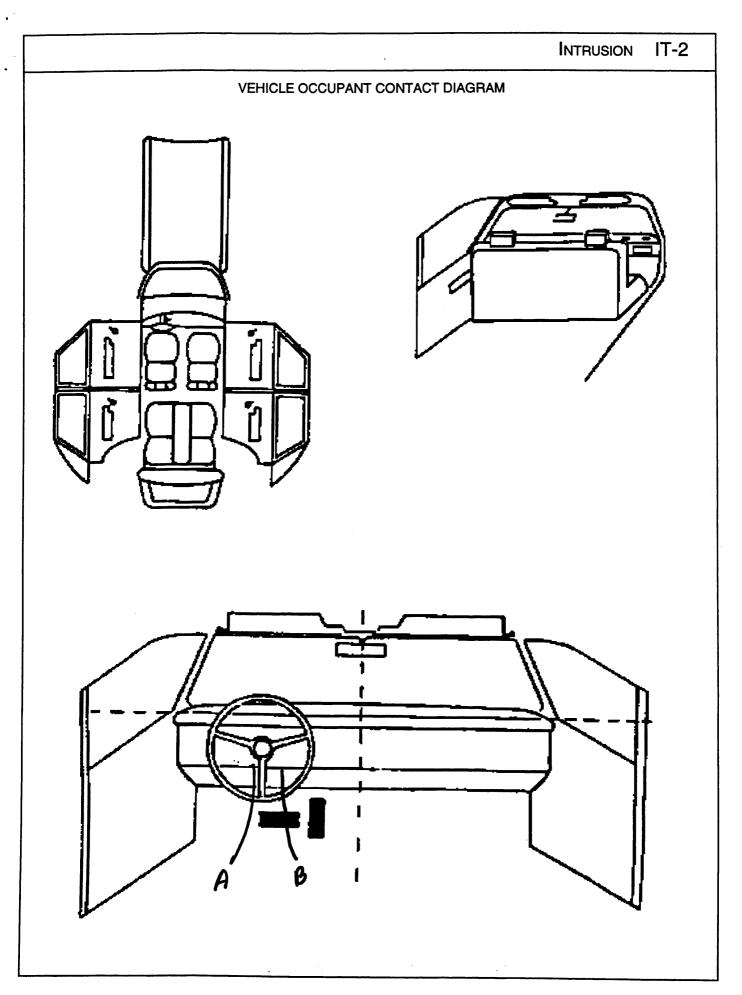
Location	of		Compai Valu	(All Measurements Are in rison Intruded value	·	Dominant Crush
Intrusio	on Intruded	d Component	Valu	e – Value	= Intrusion	Crush Direction
					=	
				-	=	
				_	=	
				_	=	
				-	=	
					=	
					=	
					=	
				_	=	
					=	
				_	=	
				_	=	
				_	=	
				_	=	
				_	=	
					=	
		Ø	CCUPANT C	CONTACT WORKSHE		
Contact	Interior Component Contacted	Occupant No. if Known	Body Region if Known	Supporting	Physical Evidence	Confiden Level o Contac Point
Α	Kwee bokka	Dn	Rt. Knee	Scuff, Clothe impaint		1
В	Kuce bolsten	"	Lt. Knee	scuff		1
С						<u>`</u>
D						
Е						
F						
G						
Н						
						1

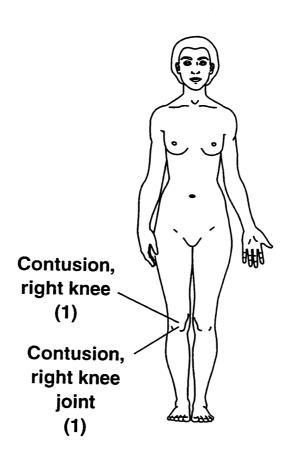
INDICATE LOCATION OF INJURIES.

The driver sustained a contusion to her right knee and right knee joint due to contact with the knee bolster below the steering column, (slides 43 and 44), as evidenced by a scuff mark and cloth imprint on the plastic knee bolster cover.

Injury Source		
Injury Description	A.I.S.	Definite	Probable	Possible
Contusion, right knee	1	Knee bolster		
Contusion, right knee joint	1	Knee bolster		
Maximum A.I.S. Level	1			
Injury Severity Score	2
